## **MEMORANDUM**

DATE: 2 December 2010

RE: Site Reconnaissance Activities at the Allied Platers Site, Hartford, Hartford County, Connecticut. TDD Number (No.) 01-09-04-0010; Task No. 0541; Document Control (DC) No. R-6479.

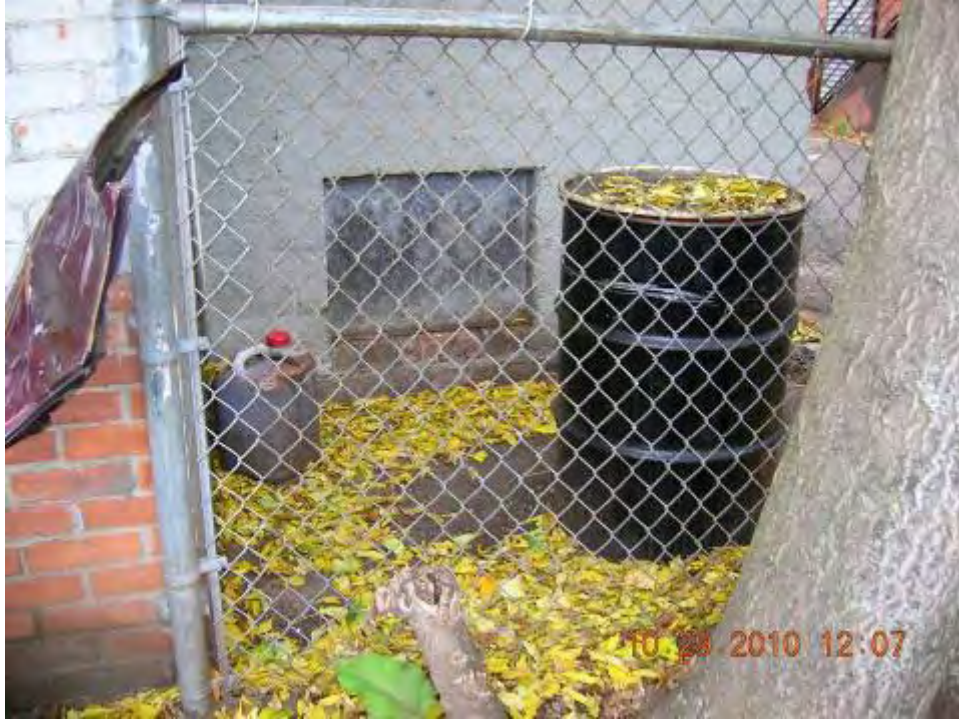
**SCENE:** View of a 55-gallon steel drum and a 2.5-gallon polyethylene jug containing used cooking oil and grease. Photograph taken facing northwest.

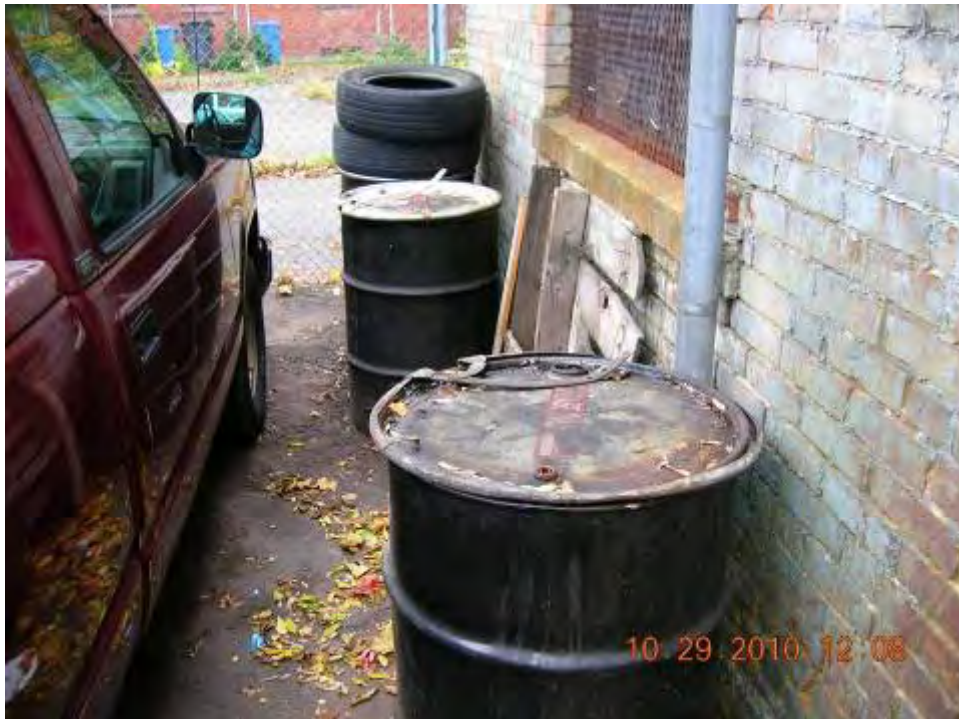
**SCENE:** View of three 55-gallon drums containing suspected used motor oil staged along the eastern exterior wall of the former plating shop. Photograph taken facing south.

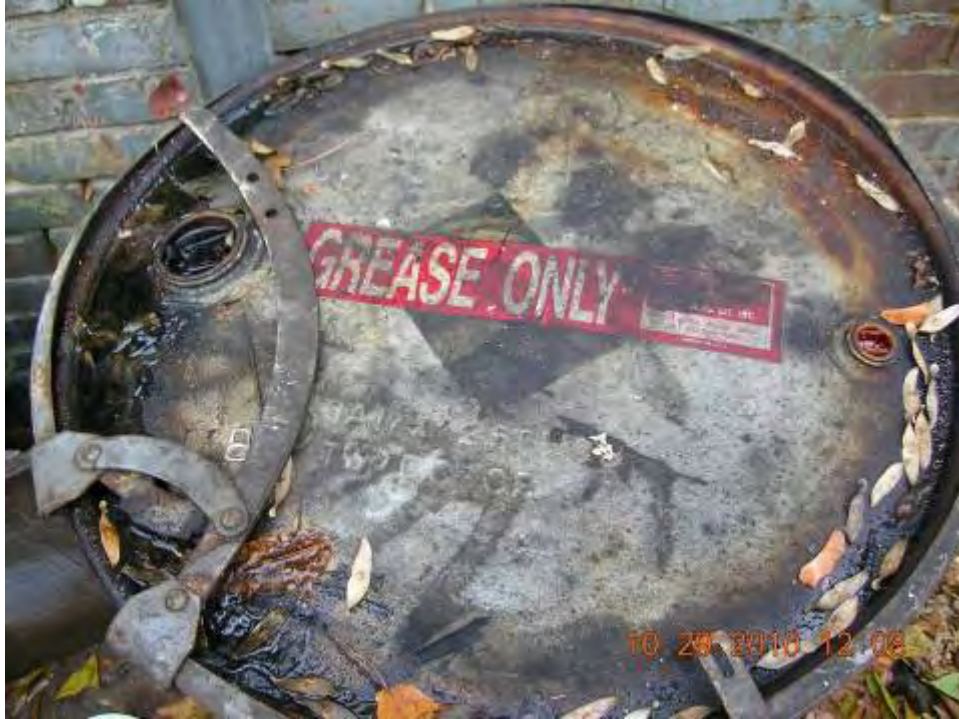
**SCENE:** View of the top of one of the 55-gallon drums containing suspected used motor oil.

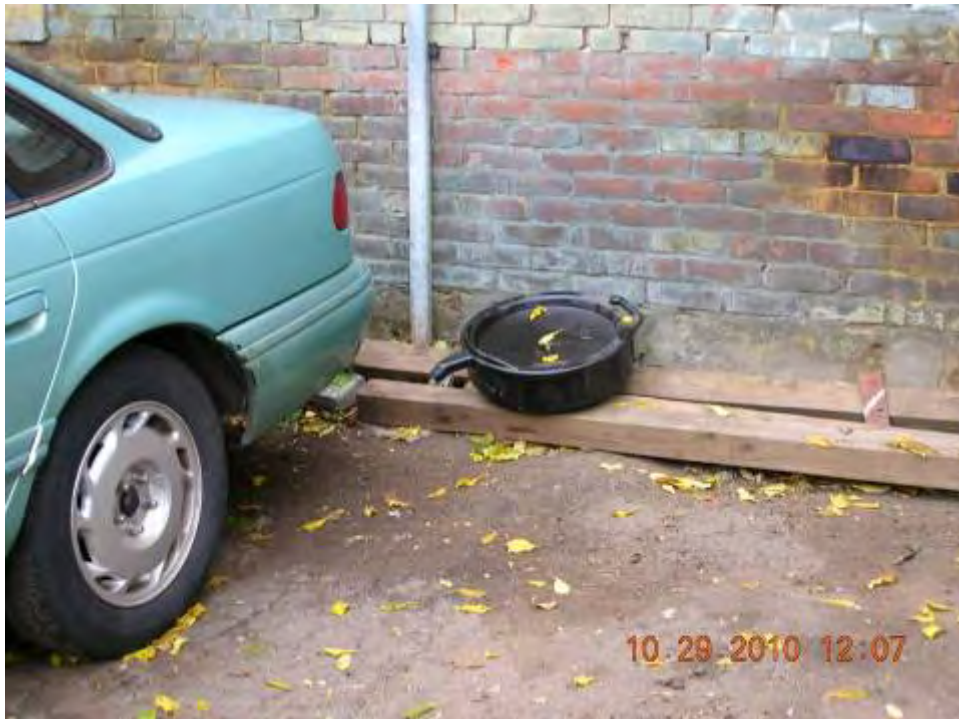
**SCENE:** View of an automotive oil receptacle staged along the eastern exterior wall of the former plating shop. Photograph taken facing west.

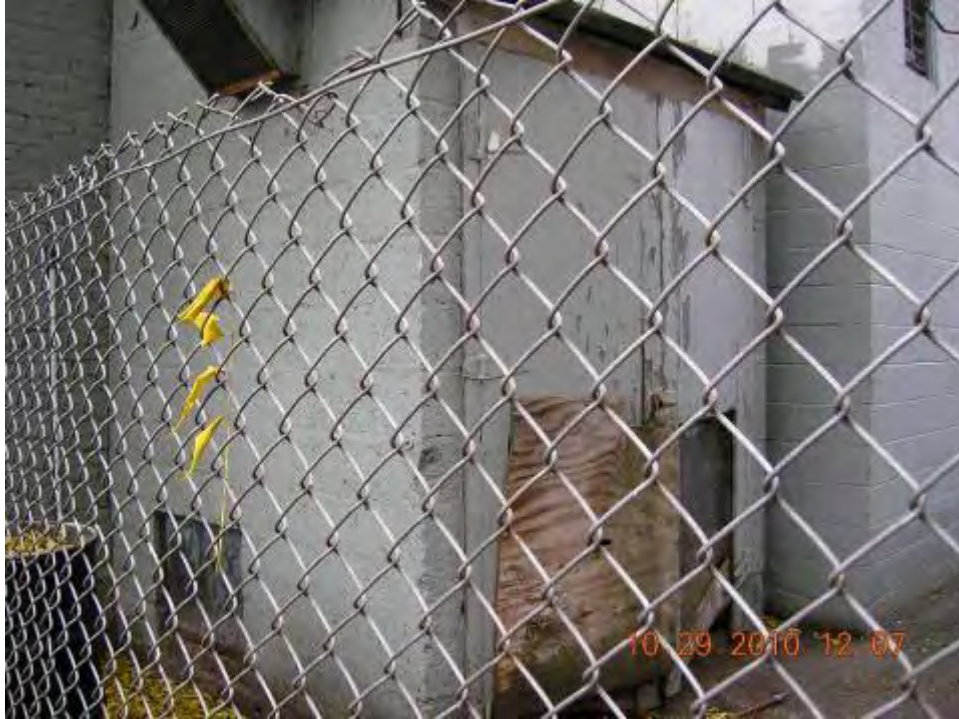
**SCENE:** View of the wooden storage shed that contained up to 20 5-gallon polyethylene containers of used cooking oil and grease. Photograph taken facing southwest.

EPA and START personnel exited the building, re-secured the plywood over the entrance doorway, and reported the findings to the City and CTDEP representatives. Follow-up actions have included reporting the storage of cooking oil and grease to the City of Hartford's inspectional services, and compiling a Memorandum to the Site File detailing the finding of the site reconnaissance to EPA.

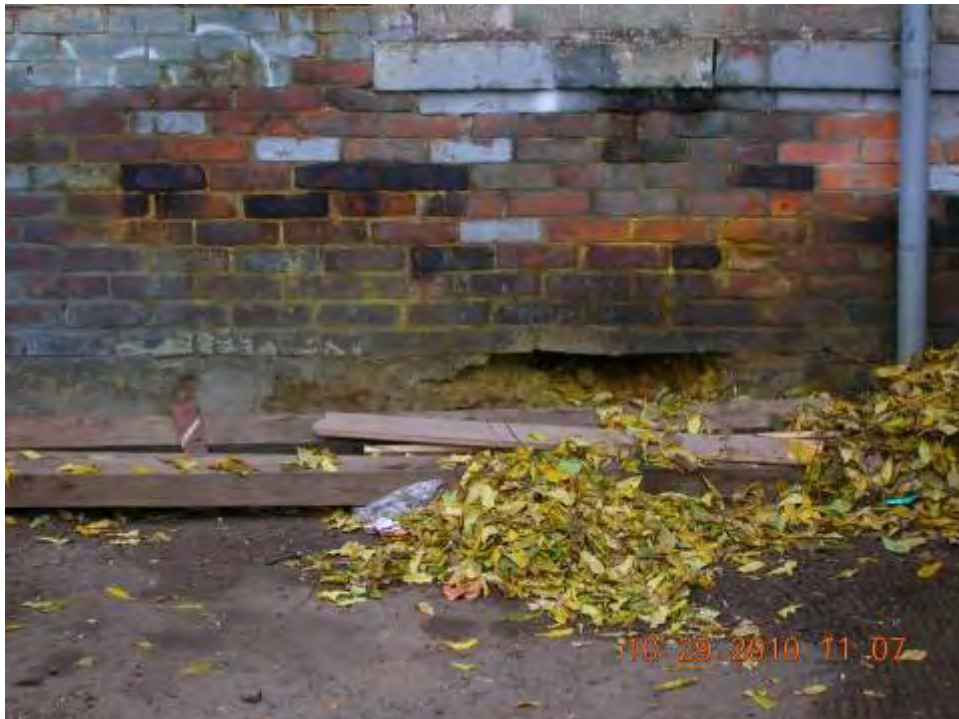
**SCENE:** View of the eastern exterior wall of the former plating shop that shows yellow discoloration. Photograph taken facing west.

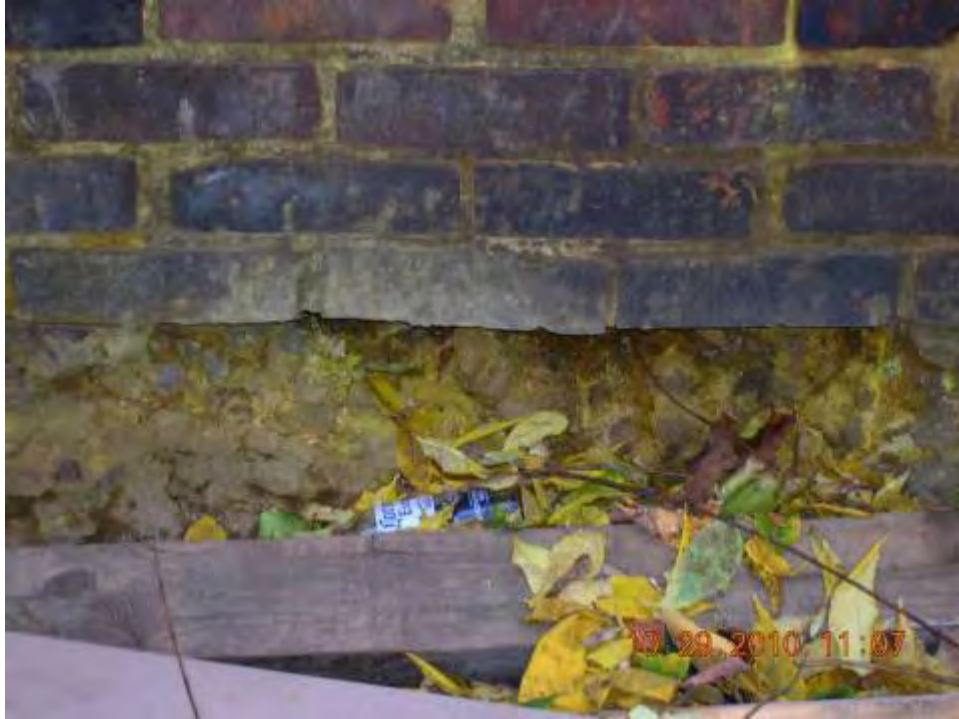
**SCENE:** Close-up view of the yellow-stained eastern wall of the former plating facility.

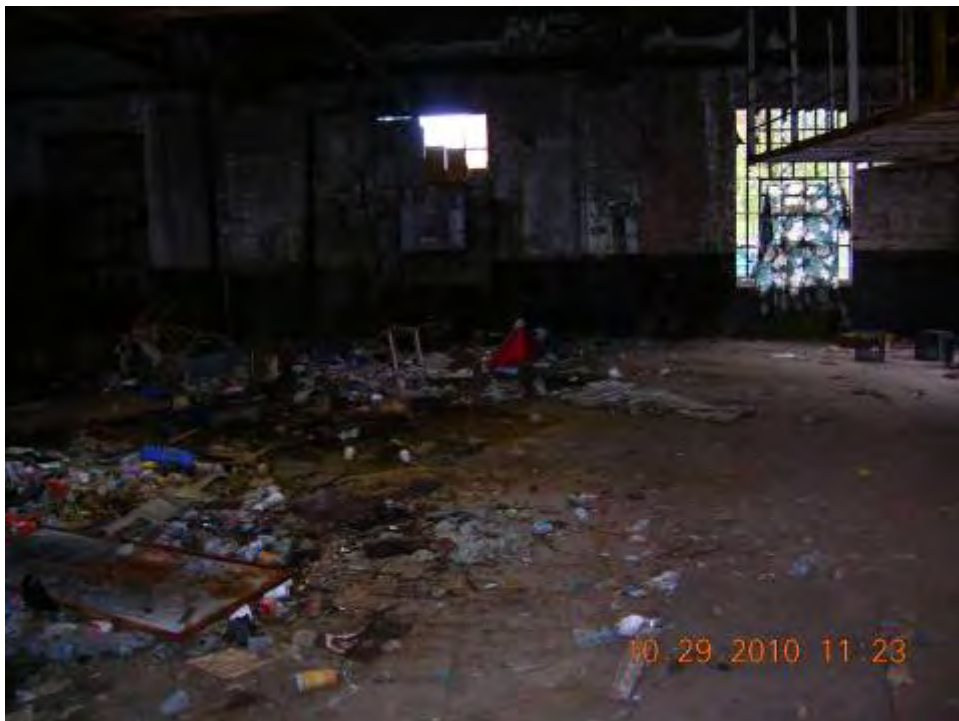
EPA and START personnel entered the building and noted that sections of the roof were missing. The interior concrete floor of the building was stained with a yellow residue, was covered with debris and trash, and was broken in some areas by the apparent removal of the plating vats. The broken concrete floor also exposed sub-slab soil. In addition, several hypodermic needles were observed within the building, and the odor of cooking grease was detected. Further investigation of the storage area along the northern portion of the building revealed that there were up to 20 5-gallon polyethylene containers staged within that area; the containers were suspected to contain used cooking oil. EPA and START personnel also noted that there was a crawl-space basement beneath the building, that up to 2 feet of standing water was in the basement, and that the furnace formerly used to heat the building was located within this area.

**SCENE:** View of the interior of the former plating facility. Photograph taken facing east.

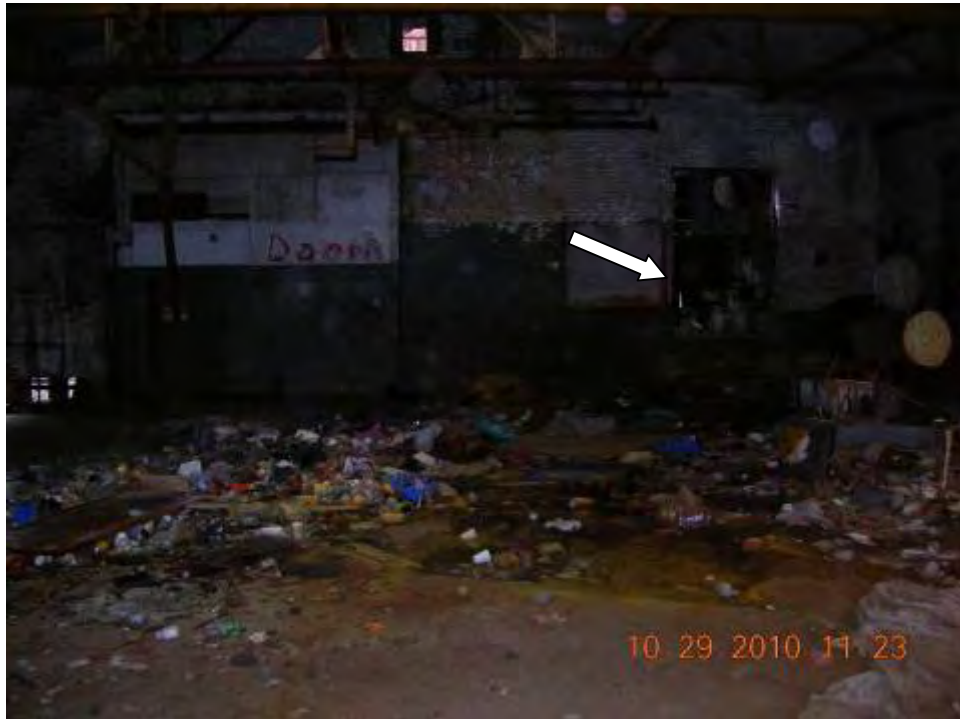
**SCENE:** View of the interior of the former plating facility. Note the arrow that indicates the opening along the northeast wall and the 5-gallon polyethylene containers of used cooking oil and grease. Photograph taken facing north.

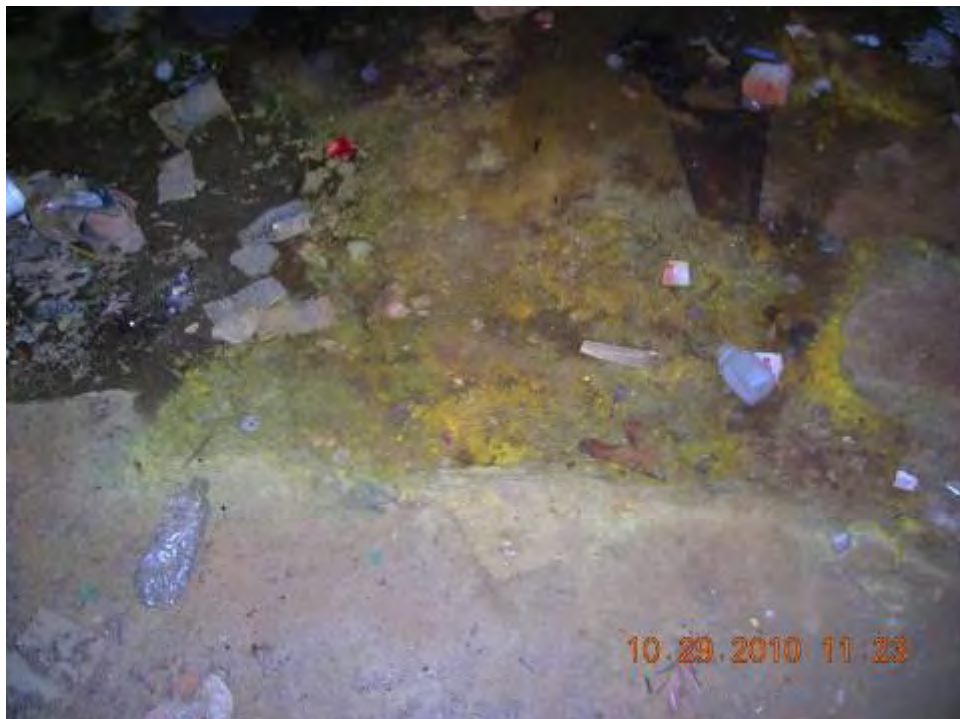
**SCENE:** View of the yellow staining of the floor of the former plating facility.

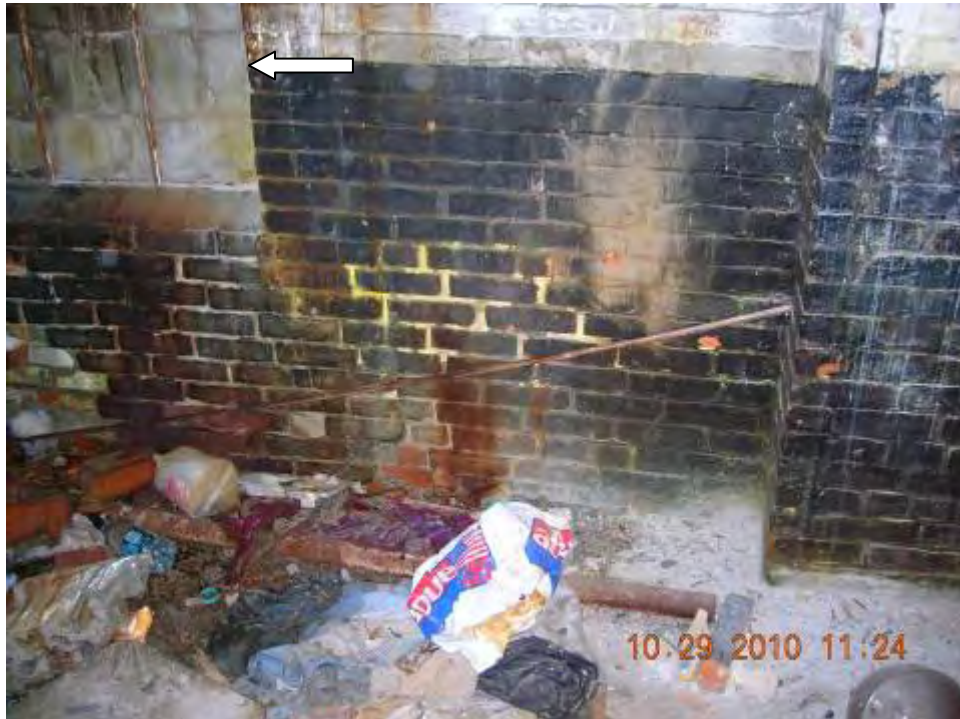
**SCENE:** View of the interior eastern wall of the former plating facility. Note the arrow that indicates the opening of the window that has been secured with brick and mortar. Photograph taken facing northeast.

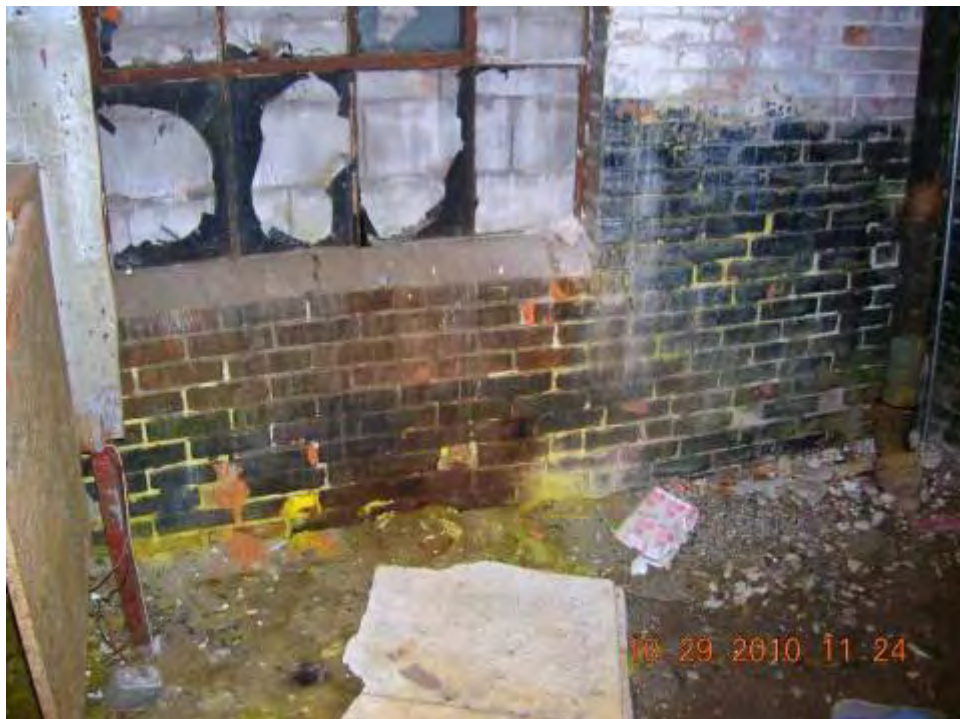
**SCENE:** View of the yellow staining along the interior eastern wall of the former plating facility. Photograph taken facing east.

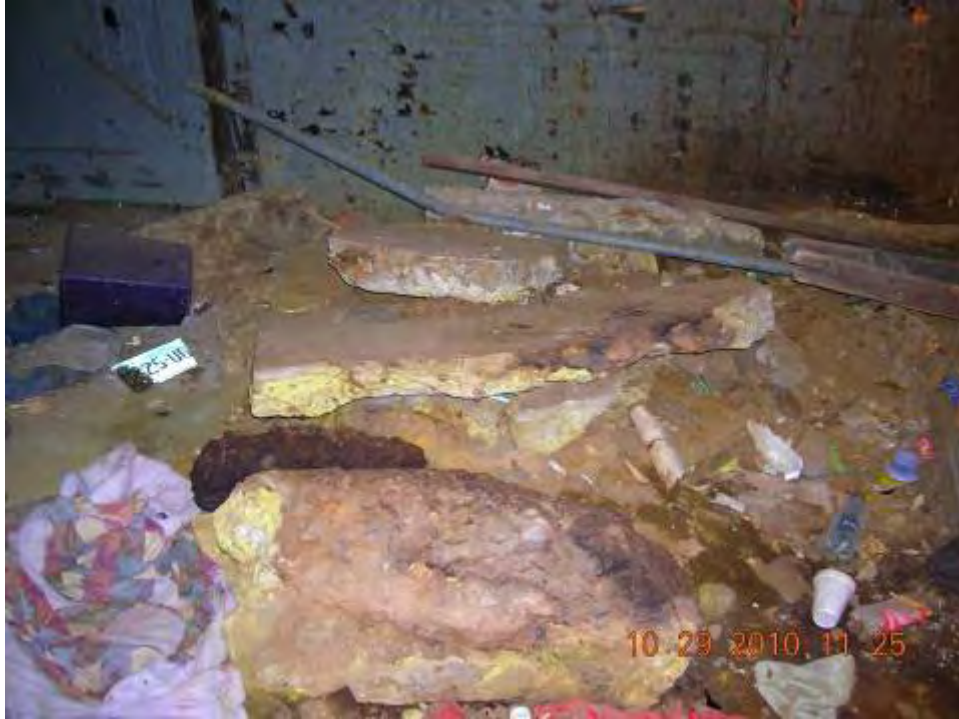
**SCENE:** View of the broken concrete flooring of the former plating facility that was suspected to be a result of the removal of the plating vats. Photograph taken facing north.

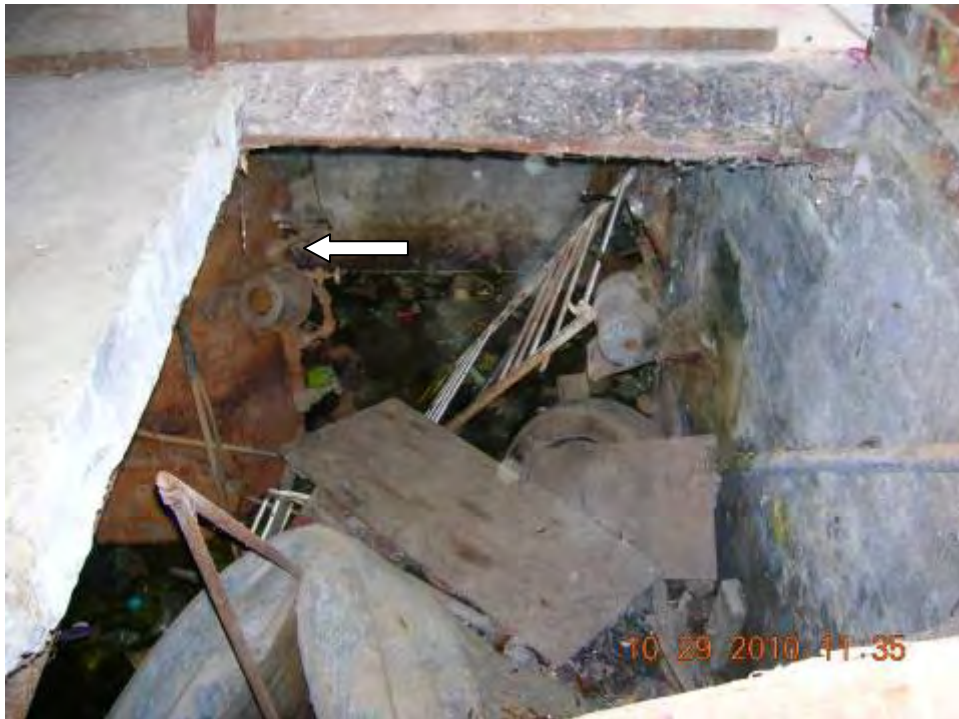
**SCENE:** View of the entrance to the crawl space and the furnace (arrow) for the former plating facility.
